Chang, W-S 2015, 'Repair and reinforcement of timber columns and shear walls - A review', *Construction and Building Materials*, vol. 97, pp. 14-24. <https://doi.org/10.1016/j.conbuildmat.2015.07.002>

Wen-Shao Chang

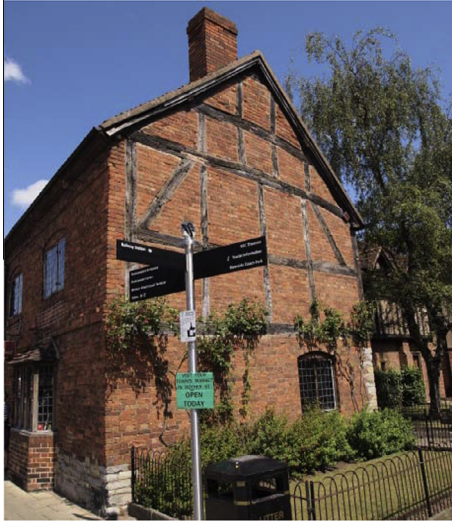
Fig. 1. Half-timber frame with brick infill.

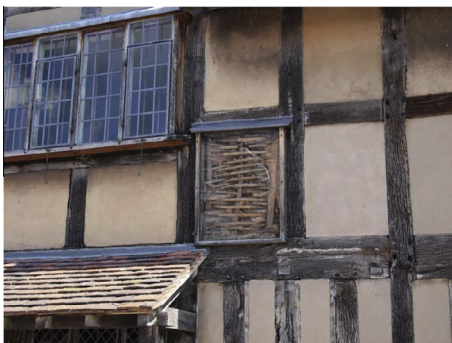
Fig. 2. Half-timber frame with wattle and daub infill.

is an important structural element that provides lateral stability to the structure and resists horizontal forces, such as earthquake and wind. They provide substantial in-plane stiffness and only limited out-of-plane stiffness. The reasons to reinforce timber shear walls are: (a) to enhance stiffness and strength; (b) to improve ductility; and (c) to increase energy dissipation capacity. Note that in this paper only shear walls made of timber will be discussed. For example, in some half-timber framed structures, stones, bricks (Fig. 1) and wattle and daub (Fig. 2) are often used as in-fill elements and therefore are outside the scope of this paper.

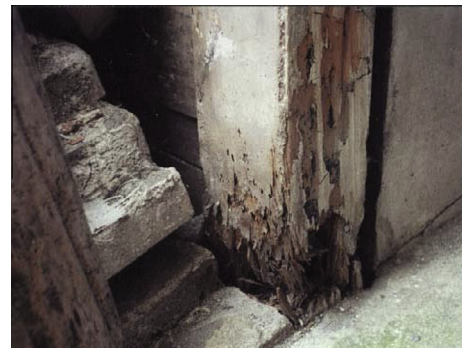
Fig. 3. Bio-deterioration in a column that has contact with the ground.

Columns, when touching the ground without any measure to isolate them from damp, are prone to elevated moisture content levels which will lead to bio-deterioration due to insects (such as termites) and fungal attacks. This is a common form of decay that can be found where the column touches the ground (Fig. 3). Although it is advisable when designing a timber column to select

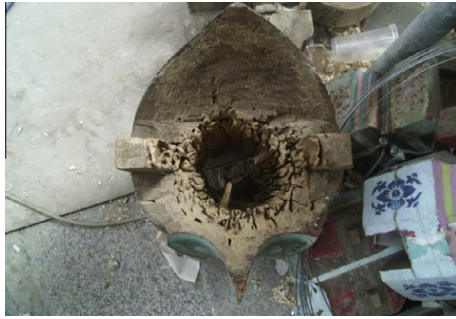
Fig. 4. Timber strut attacked by termites.

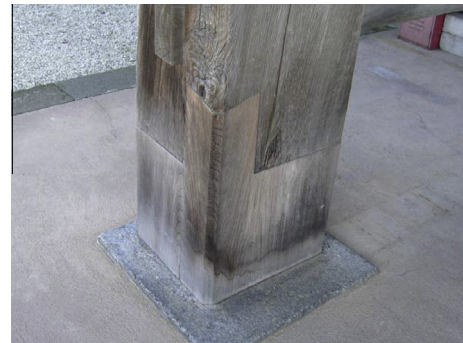
Fig. 7. A new timber component was used to partially replace a rotten column with traditional carpentry.

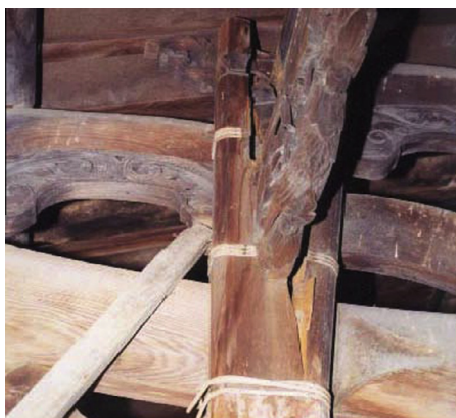
Fig. 5. A column damaged due to an earthquake.

Compared with beam members, creep is less onerous in a column member. A column normally takes only vertical load; in some circumstances it will take combined compression and bending. The former will lead to buckling or crushing failure of the column, whilst the latter will result in partial yielding or split along the grain, as shown in Fig. 5. Slender compression members are

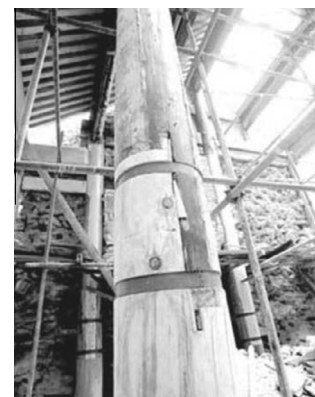
Fig. 8. Partial replacement repair in Dabai Temple (1550), China [4].

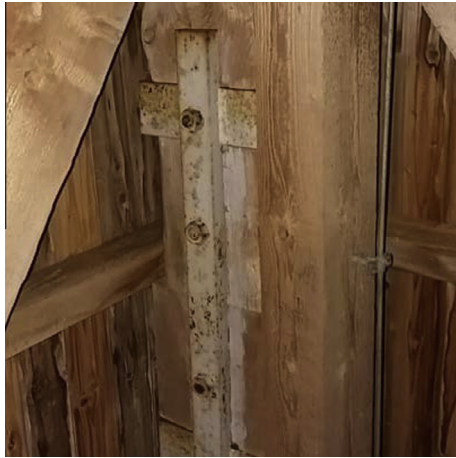
Fig. 11. Steel members are used to connect two columns to transfer load.

In the early stages of reinforcement and repair of timber structures, the focus was mainly on using metallic reinforcement, such as steel bars and plates. The idea of using steel members to reinforce a timber column is to: (a) facilitate a timber column to carry or transfer load (Fig. 11); and (b) to prevent crack to split. The common forms of steel reinforcement include: (a) steel plate with nails or screws; (b) punched metal plates; and (c) steel glued-in rods. However, the focus was mainly on beam elements and connections; efforts being devoted to the reinforcement of columns were relatively scarce. Tanaka et al. compared the effect of a column reinforced by steel plate with that of one reinforced by carbon fibre sheets [6].

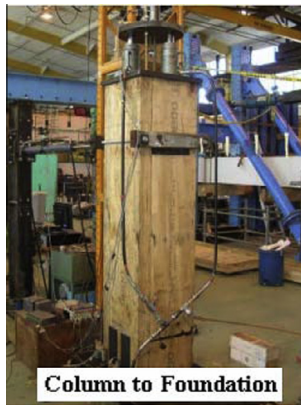
Fig. 17. Column to foundation specimen with post-tensioned reinforcement and external energy dissipater [18].

capacity after a column has undergone large deformation. An extensive experimental campaign was carried out on beam-to-column, column-to-foundation and wall-to-foundation subassemblies for the implementation of LVL hybrid solutions [17,18]. The design was to use external energy dissipaters together with post-tensioned effect to provide re-centring and energy dissipation capacity of a timber column. Figs. 17 and 18 show the specimens and experimental setup, respectively.

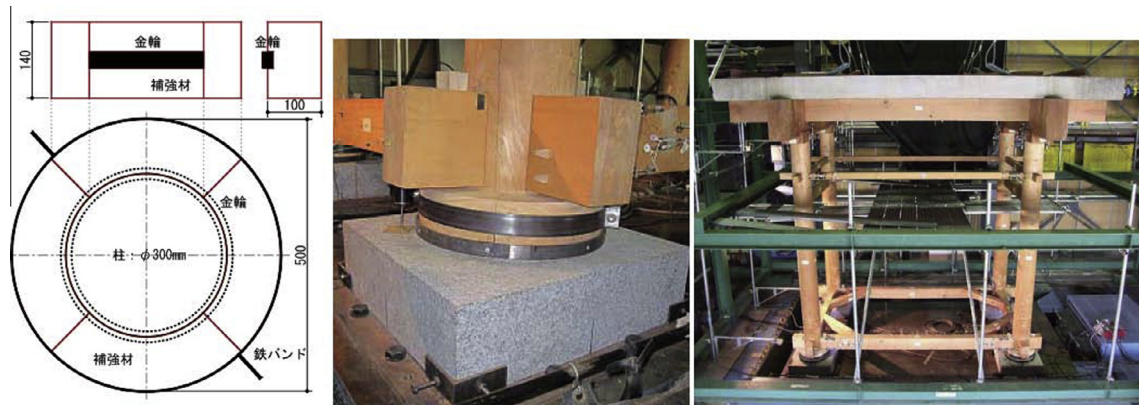
Fig. 20. Enlargement of column base proposed by Suda, Tasiro and Suzuki [20].

Enlargement of the cross section of a column will help to reduce stress within the column so as to reduce the potential for buckling and material yield in compression. In some structures, such as those found in Japanese temples, large section columns will contribute to resisting lateral load by providing restoring forces [19]. Suda, Tasiro and Suzuki [20] proposed to enlarge the column base of existing structures (Fig. 20) to increase the restoring force, which helps the column to return back its original position from its movement, so as to enhance the aseismic behaviour of traditional temples.

Shaking table tests were carried out to investigate the effectiveness of the proposed reinforcement method. The reinforced column shows higher restoring force at the same deformation. A column with diameter of 300 mm was used, and the column base was increased to 400 and 500 mm as reinforcement. It showed,

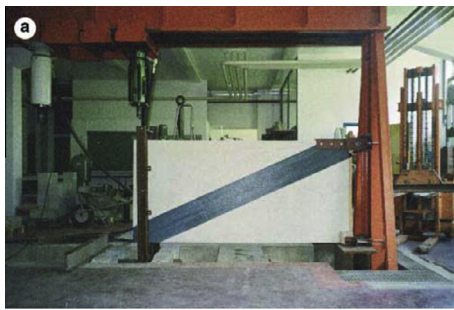
Fig. 21. The specimen and test setup for CFRP reinforced timber shear walls [23].

A series of research programmes have been carried out on reinforcing timber shear walls using FRP strips by experiments and numerical analyses [22,23]. A total of nine specimens were tested in three groups and the CFRP strips were glued on the fibre-plaster board (FPB) attached to the timber frames [22]. Fig. 21 shows the specimen for the tests. The first group (G1) used two CFRP diagonal strips with width of 300 mm glued on to the FPB and also onto the timber frame; whereas the second group (G2) used 600 mm wide CFRP diagonal strips with the other conditions being the same as the first group. The third group (G3) has two 300 mm width CFRP strips glued on the FPB but not attached to the timber frame. The experimental results revealed that the third group had the highest elastic resistance (force forming the first crack) although it was found to increase in all the CFRP strengthened test samples. The results from this series of tests showed that the three reinforcement methods do not increase the stiffness but increase the strength. An analytical model has been further developed to approximate the behaviour of timber shear walls reinforced by CFRP strips with satisfactory agreement [23].
